*** Residential Inspection Report ***

123 SAMPLE WAY
Henderson, NV 89074

Date Of Inspection: October 30, 2015

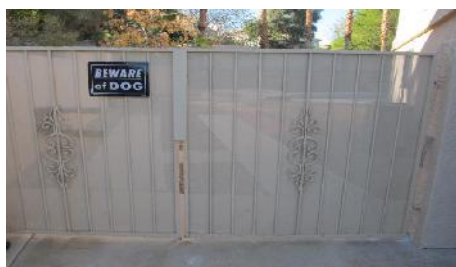
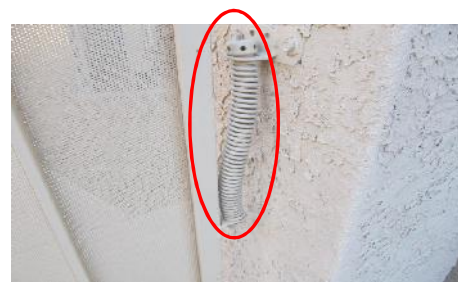
Further Comments: Due to this gate being the only access to backyard, and the presence of a pool, recommend adjusting spring so that the gate auto closes. Recommend consulting with local jurisdiction for current pool safety codes and repair accordingly.

- Due to this gate being the only access to backyard, and the presence of a pool, the gate should auto-close. . Recommend consulting with local jurisdiction for current pool safety codes and repair accordingly.

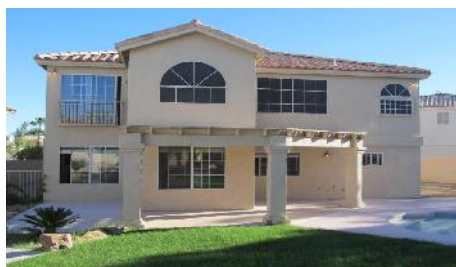
Further Comments: Common cracks and chips. Cosmetic only.

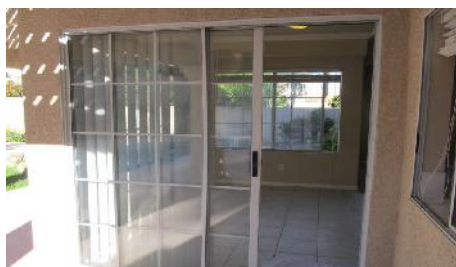
Further Comments: Sliding glass door is difficult to latch. Recommend repair for proper operation.

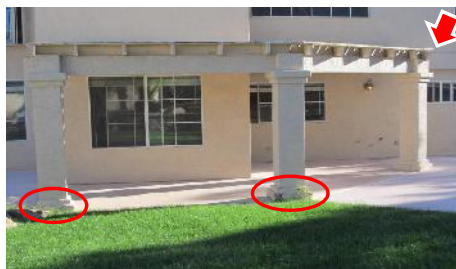
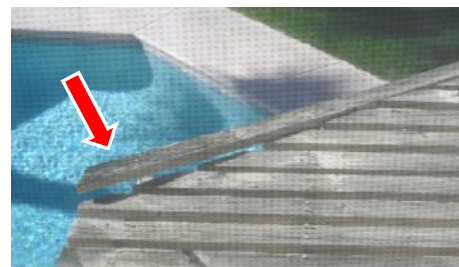
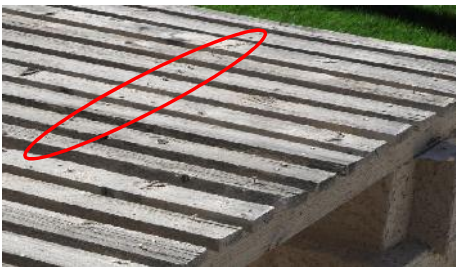
Further Comments: Bottom of pillars of patio cover are damaged from sprinklers. Recommend adjusting sprinklers to ensure they do not reach pillars to prevent further damage. Recommend repair of area to prevent water penetration. Top right corner of patio cover has a small detaching section as pictured in image 3. Recommend repair. Several nails are detaching on top of patio cover. Recommend repair.

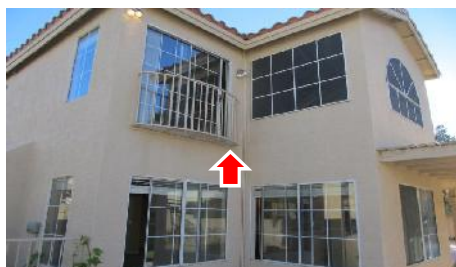
Further Comments: Balcony off game room at second floor has detaching mesh as pictured on image 2. Recommend repair.

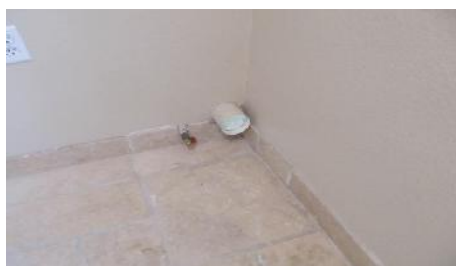
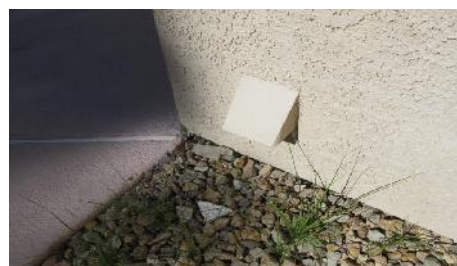
Further Comments: Vent outlet does not have damper door. Recommend replacing door to prevent pest intrusion.

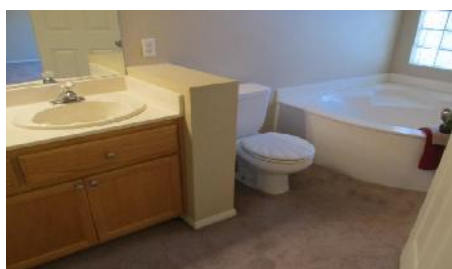
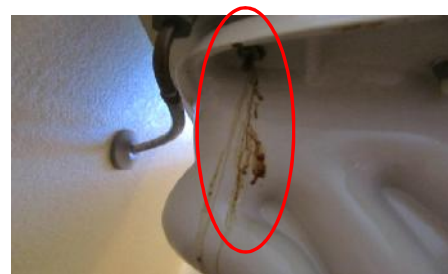
Further Comments: Master bathroom toilet has presence of rust from possible leak at bottom as pictured in image 3.
 Recommend repair.

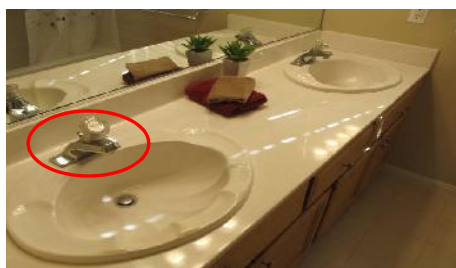
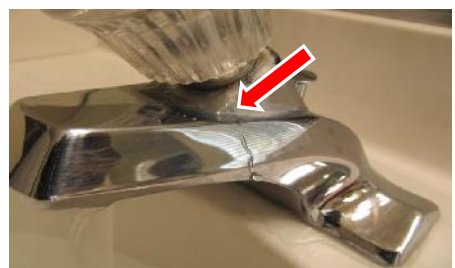
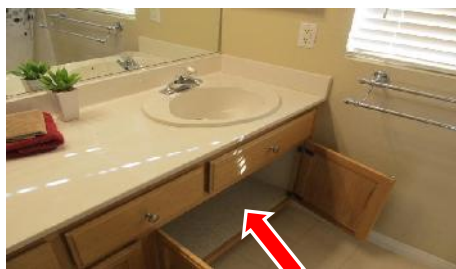
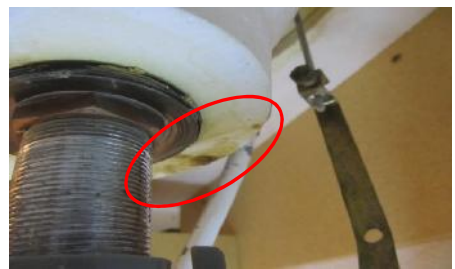
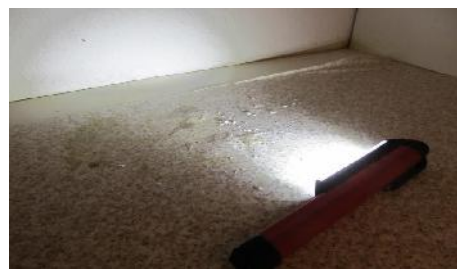
Further Comments: Faucet at left sink in hall bathroom has a leak and leak present under sink on right side as pictured. Recommend repair.

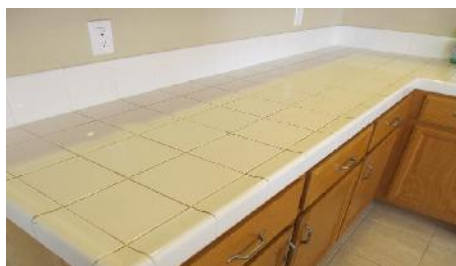
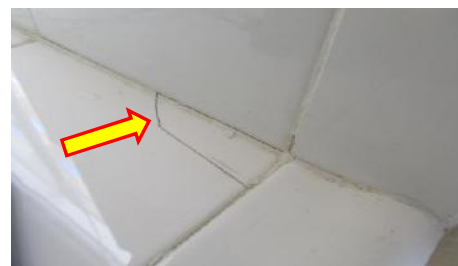
Further Comments: Two small cracks observed on tile in kitchen. Cosmetic only.

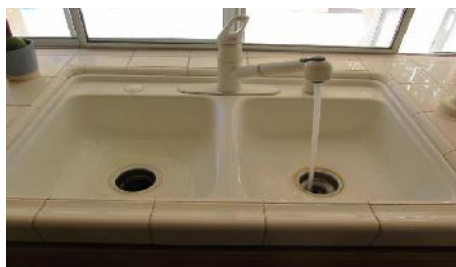
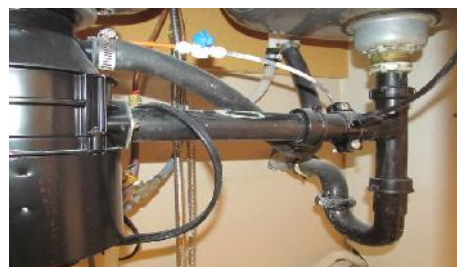
Further Comments: Kitchen faucet has slow drip. Recommend repair.

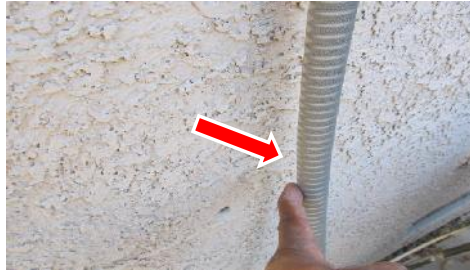
AC was fully operational at time of inspection. Recommend properly anchoring electrical conduit line and replacing insulation around copper tubing.

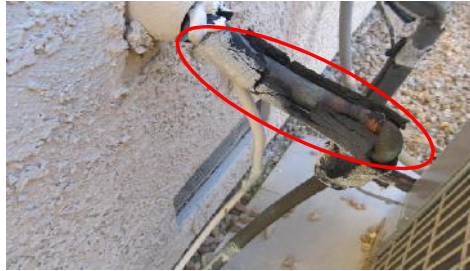
AC was fully operational at time of inspection. Recommend properly anchoring electrical conduit line and replacing insulation around copper tubing.

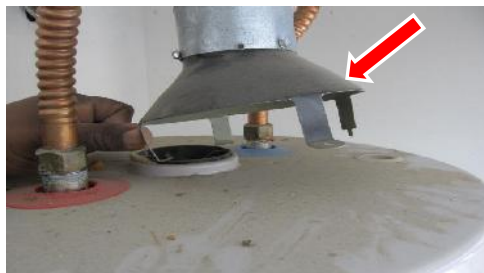
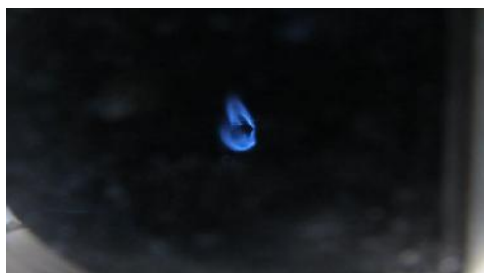
Vent hood on water heater is not properly attached as pictured in image 2. Minor repair needed.

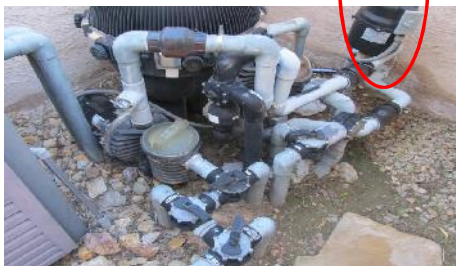
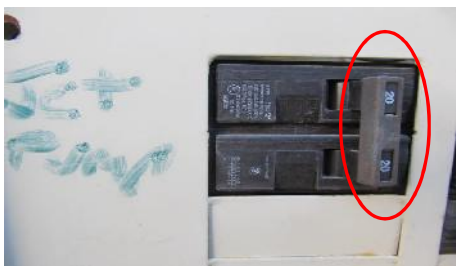
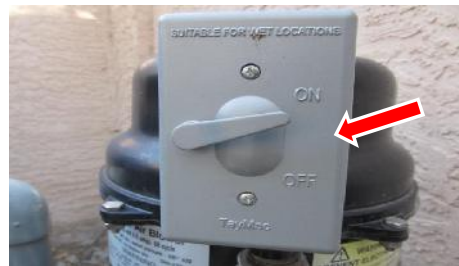
Further Comments: Spa jets are operated via breaker. No switch present on panel to operate. Recommend further evaluation and repair by a qualified professional. Switch for spa blower pictured in image 4 was not operational. Recommend repair by qualified professional.

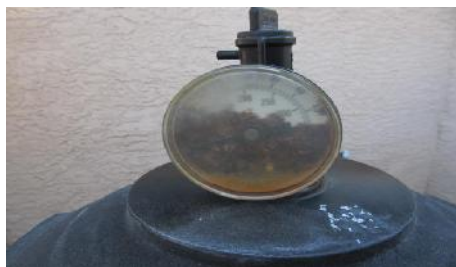
Pressure Gauge

Further Comments: Pressure gauge is rusted on the inside making it difficult to read. Recommend replacing.

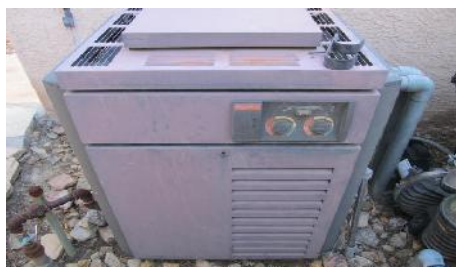
Further Comments: Heater powered on but did not fire. Recommend further evaluation and repair by a qualified professional.

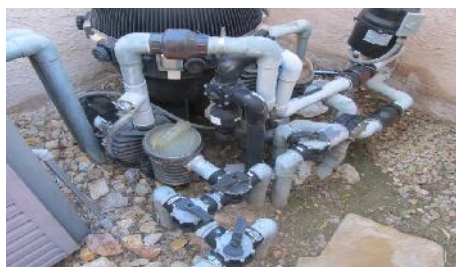
Further Comments: Several leaks observed at pool plumbing pictured in image 1. Leak at top of filter housing pictured in image 2. Recommend repair by a qualified professional.

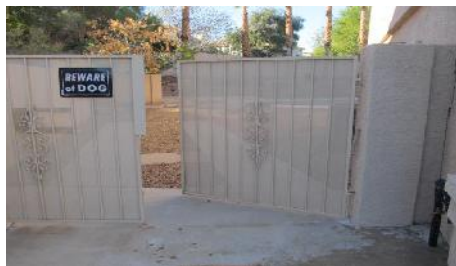
Further Comments: Due to this gate being the only access to backyard, and the presence of a pool, recommend adjusting spring so that the gate auto closes. Recommend consulting with local jurisdiction for current pool safety codes and repair accordingly.
