Buyer's Choice Home Inspections LLC

*** Residential Inspection Report ***

March 30, 2019

777 Dream View Ave.
Las Vegas, NV 89147

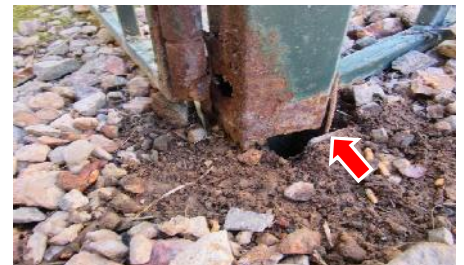
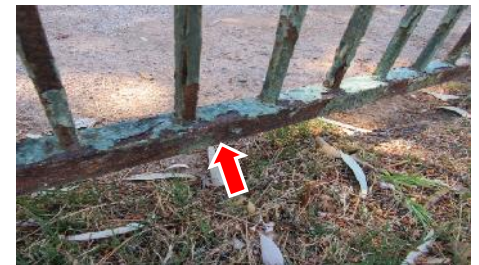
Further Comments: Gate at left side of home pictured in images 1-3, has missing and detaching wall anchors, no wall latch and post is rusted and detached. Recommend repair. Rear fence/gate is weathered and rusted likely from irrigation constantly hitting area. Recommend attention.

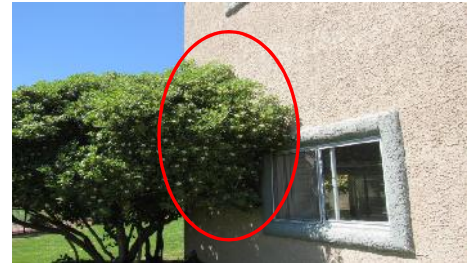
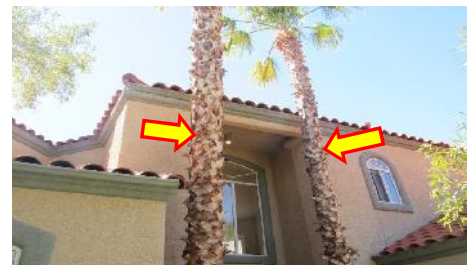
Further Comments: Recommend trimming trees away from home and roof to prevent stucco damage and to ensure proper roof drainage.

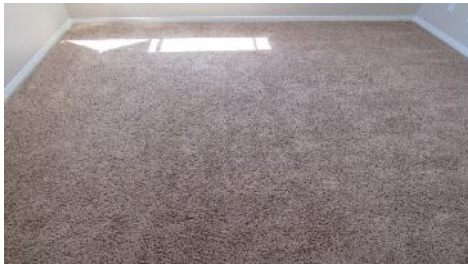
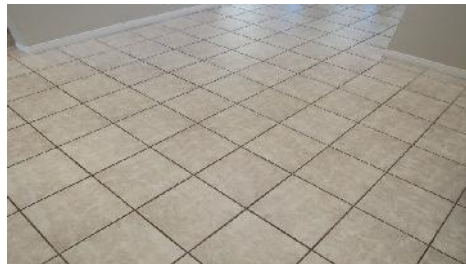
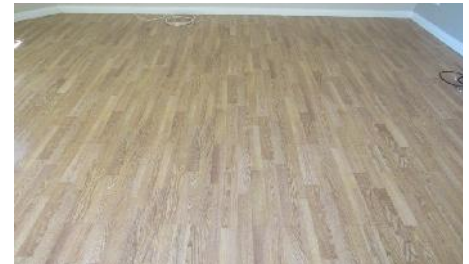
Further Comments: Tile floors throughout home have hairline cracks and chips as pictured. Cosmetic only.

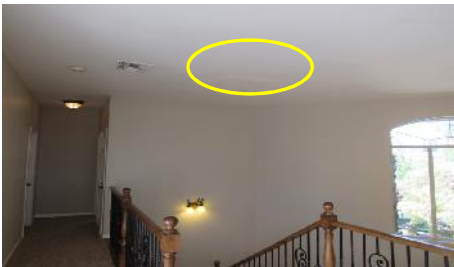
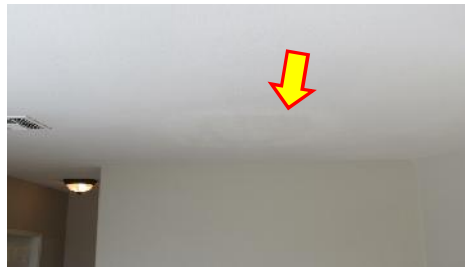
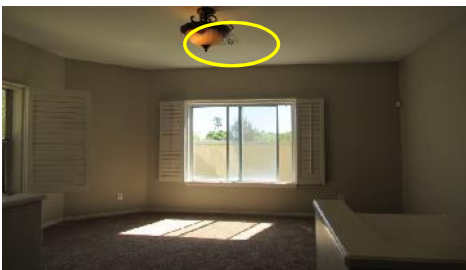
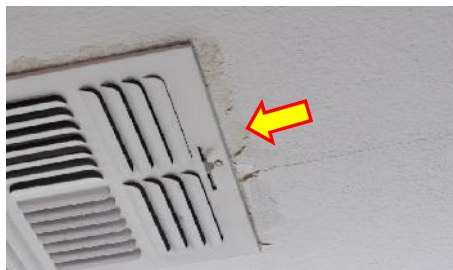
Further Comments: Previously patched area observed above staircase as pictured in images 1 and 2. Furnace is located in attic area above. Signs of previous leak observed at register in the dining room as pictured in images 3 and 4. Hall bathroom is above that area. No moisture present at time of inspection. Common settling cracks observed on areas of ceilings. Not structural in nature. Cosmetic only.

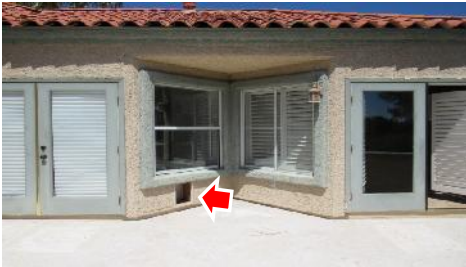
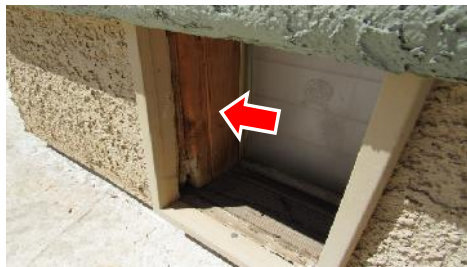
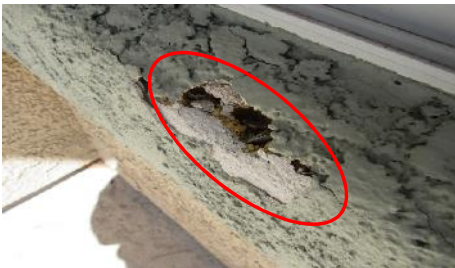
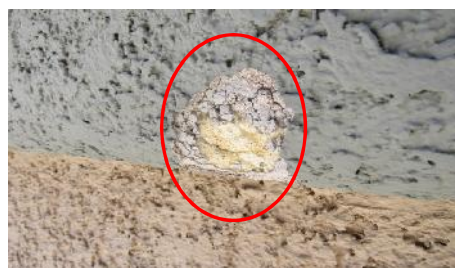
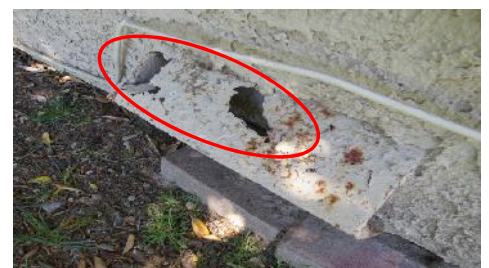
Further Comments: Pet door present at 2nd floor balcony has exposed wood as pictured. Recommend painting/sealing to prevent water penetration. Several chips observed on exterior stucco with exposed foam and underlayment. Recommend patching to prevent water penetration. Normal cracks and chips observed on exterior walls. Cosmetic only.

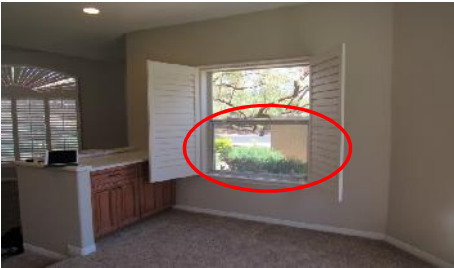
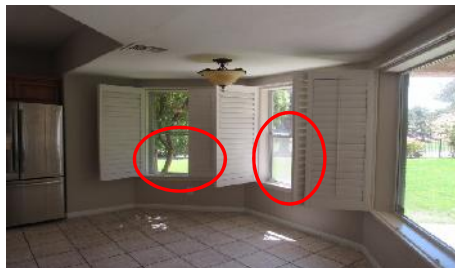
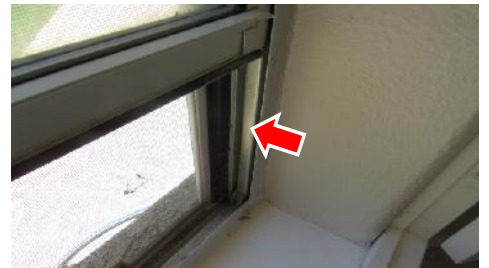
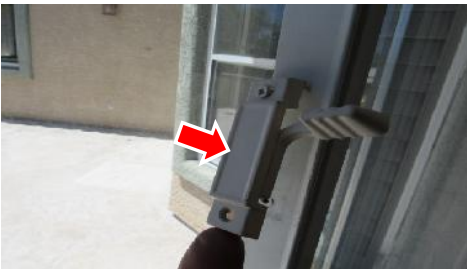
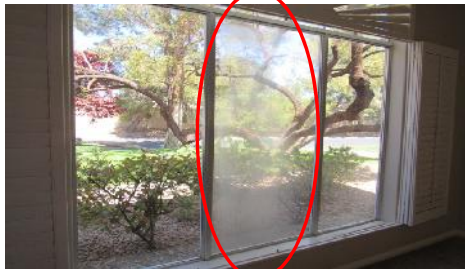
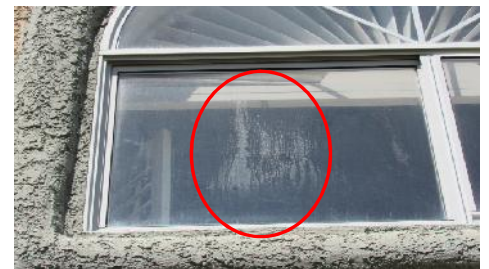
Further Comments: Dining room window and kitchen windows pictured in images 1 -3 either did not open or did not stay open due to detached glides. Recommend repair for proper operation. Master bedroom window lock detaches as pictured in image 4. Recommend repair. Front living room window and master bathroom window has condensation present between panes as pictured in images 5 and 6 which may indicate a compromised seal, likely due to age.

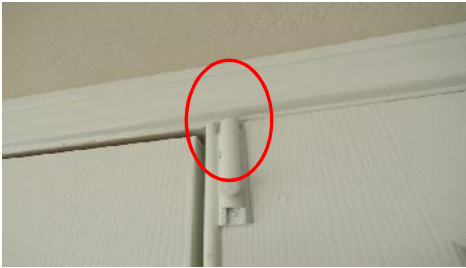
Further Comments: Master bedroom door is missing anchoring hardware causing the door to not stay closed. Recommend repair.

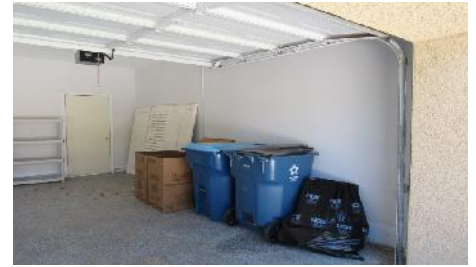
Further Comments: Common settling cracks observed on garage ceiling. Not structural in nature. Cosmetic only.

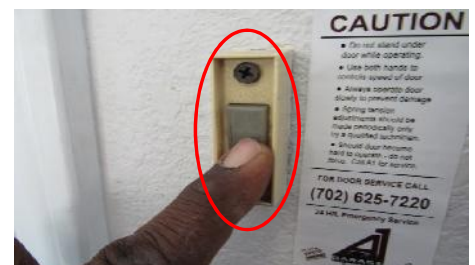
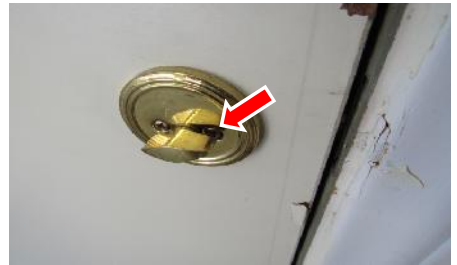
Further Comments: Single car garage door is missing sensors. Sensors should be installed in order to detect obstruction or presence of small children. Recommend correction. Buttons had to be held down for in order for the garage doors to close. Recommend repair. Door leading to interior living space from garage does not auto-close compromising the barrier from the garage to home. Recommend repair. Door leading to side yard from garage only has a deadbolt and not a knob. Door is difficult to operate. Recommend repair.

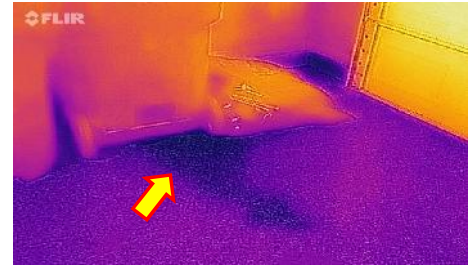
Further Comments: Puddle present in garage where pictured in image 2, moisture was likely coming from trash bag present in area.

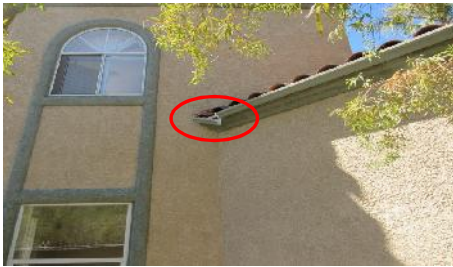
Further Comments: Gutter at left side of home is detached as pictured in image 2. Recommend repair. Recommend clearing all gutters of debris to ensure proper function.

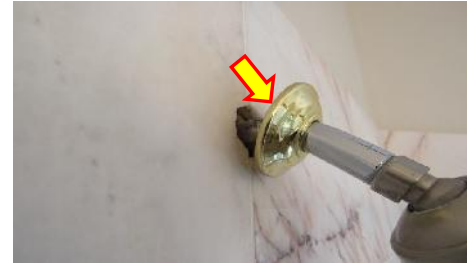
Further Comments: Master showerhead leaks as pictured in image 2 and flange is detached as pictured in image 3. Recommend cleaning and resealing around perimeter of shower pan.

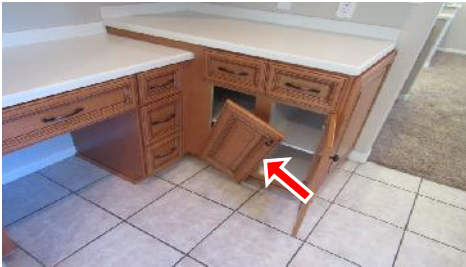
Further Comments: Kitchen cabinet door at desk is detached as pictured. Recommend repair.

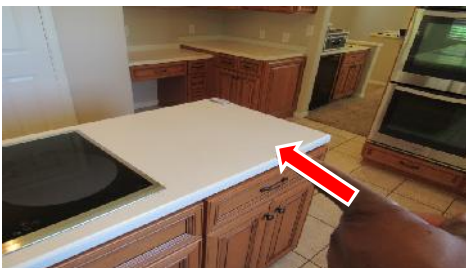
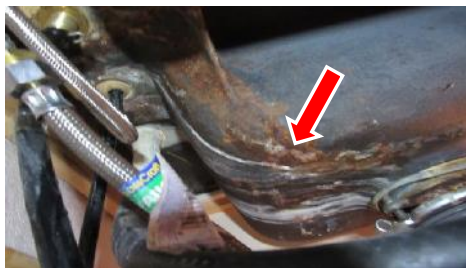
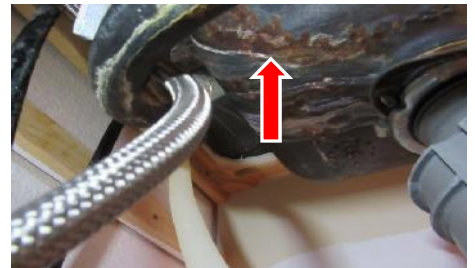
Further Comments: Countertop at stovetop has movement. Recommend repair. Underside of kitchen sink is rusted and corroded as pictured in images 2 and 3. No leaks present at time of inspection. Monitor.

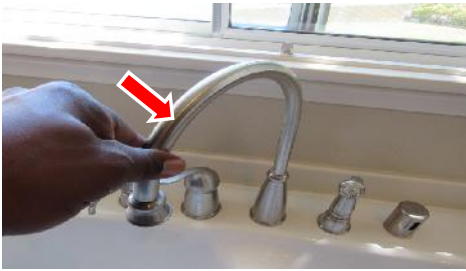
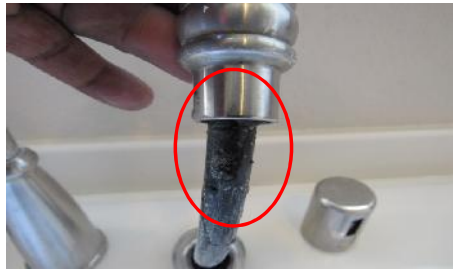
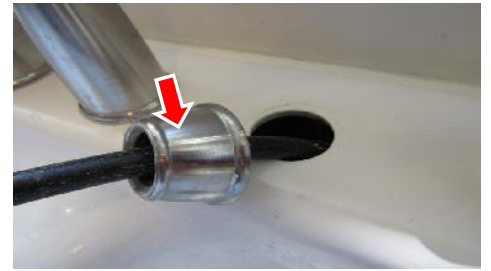
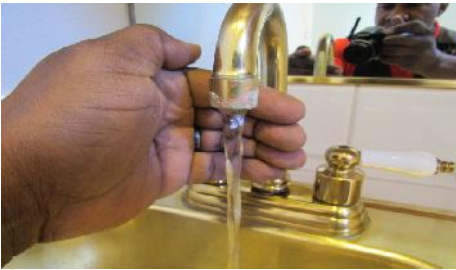
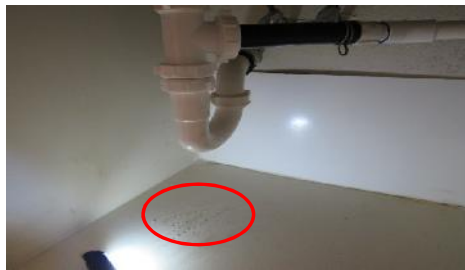
Further Comments: Kitchen faucet is difficult to turn from side to side. Recommend repair. Spray nozzle pictured in image 2 has leak present and detached flange as pictured in image 3. Recommend repair. Leak present under wet bar as pictured in image 5. Recommend repair.

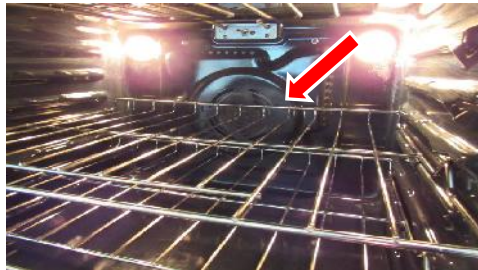
Convection oven fan emitted louder than normal sound. Recommend evaluation.

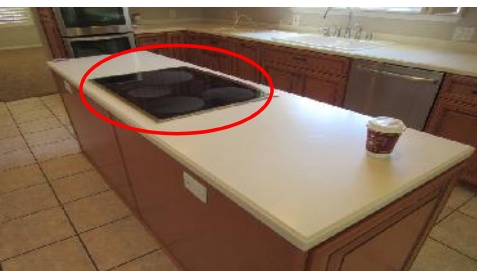
Stove powered on but went off after a short time. Recommend evaluation and repair.

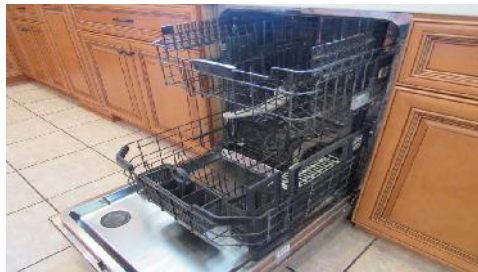
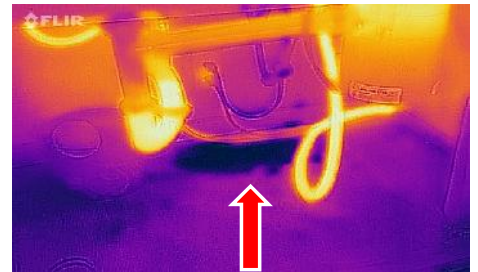
Leak present under sink when dishwasher went through drain cycle as pictured in image 3. Recommend repair.

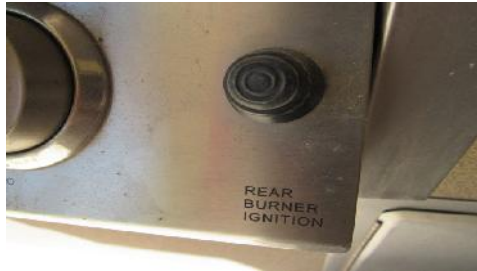
Grill igniter was not operational. Recommend repair.

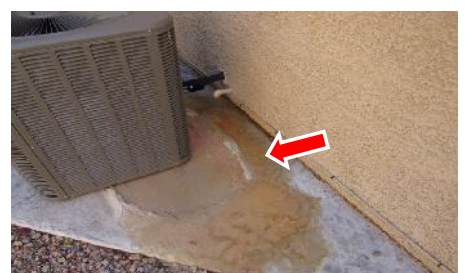
The furnace operating the 2nd floor was not operational. There should be a minimum split of 15 degrees. This unit only achieved a 3 degree split. Recommend evaluation and repair. Evidence of rust discharge present from condensation line as pictured in image 3. Recommend evaluation and servicing.

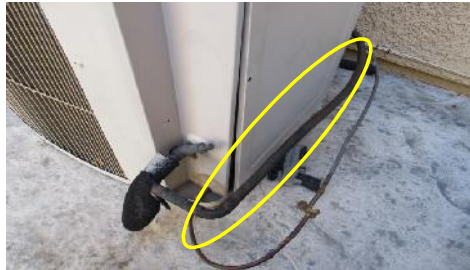
Unit was fully operational at time of inspection. Recommend insulating copper tube pictured in image 2.

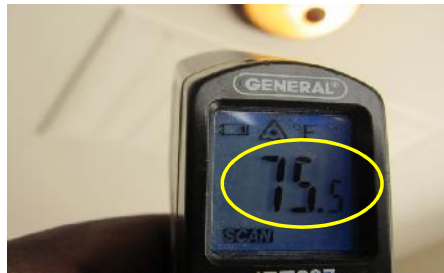
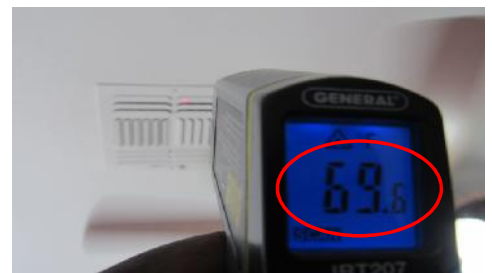
AC unit servicing the 2nd floor did not achieve optimal temperatures. There should be a minimum split of 15 degrees between return and supply air. This unit only achieved a split of 6 degrees. Recommend evaluation and repair by a qualified professional.

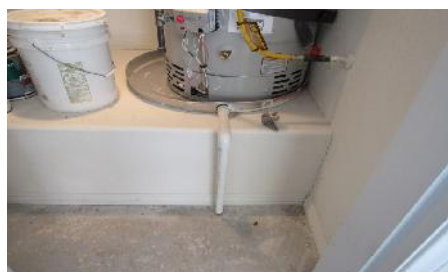
Exhaust vent for water heater is not attached as pictured in images 1 and 2. Recommend repair.
