*** Residential Inspection Report ***

123 SAMPLE WAY
Henderson, NV 89074

Date Of Inspection: October 30, 2015

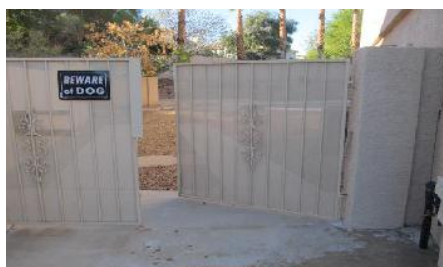
Further Comments: Due to this gate being the only access to backyard, and the presence of a pool, recommend adjusting spring so that the gate auto closes. Recommend consulting with local jurisdiction for current pool safety codes and repair accordingly.

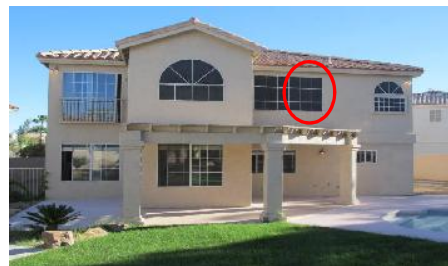
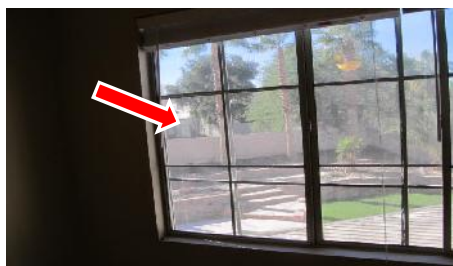
Further Comments: Unable to open window in master bedroom as pictured. Recommend repair.

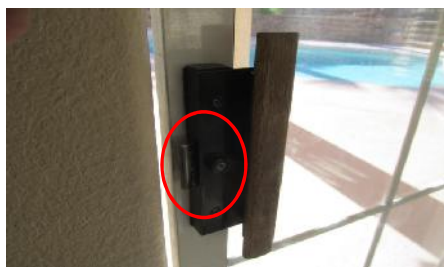
Further Comments: Sliding glass door is difficult to latch. Recommend repair for proper operation.

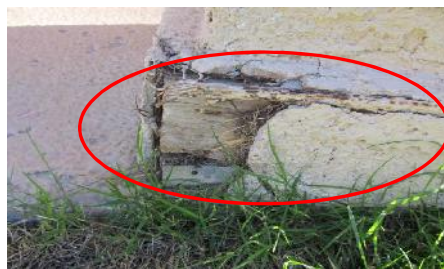
Further Comments: Bottom of pillars of patio cover are damaged from sprinklers. Recommend adjusting sprinklers to ensure they do not reach pillars to prevent further damage. Recommend repair of area to prevent water penetration. Top right corner of patio cover has a small detaching section as pictured in image 3. Recommend repair. Several nails are detaching on top of patio cover. Recommend repair.

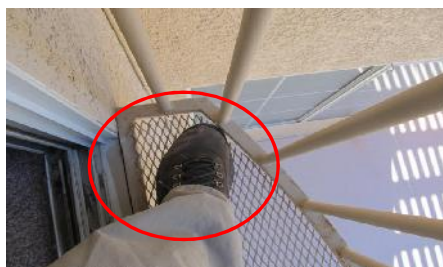
Further Comments: Balcony off game room at second floor has detaching mesh as pictured on image 2. Recommend repair.

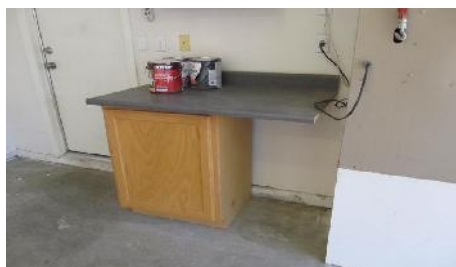
Further Comments: Cabinet and counter in garage as pictured are not anchored to wall.

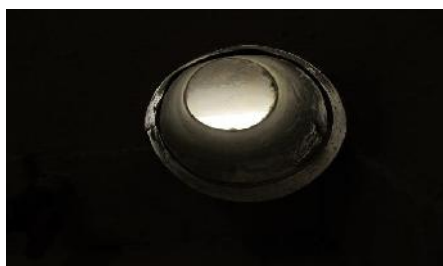
Further Comments: Vent outlet does not have damper door. Recommend replacing door to prevent pest intrusion.

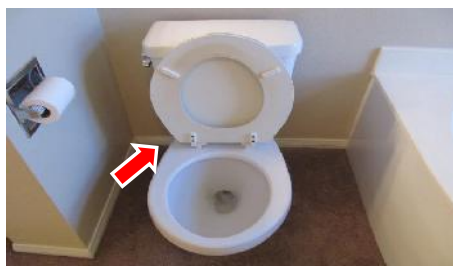
Further Comments: Master bathroom toilet has presence of rust from possible leak at bottom as pictured in image 3.
 Recommend repair.

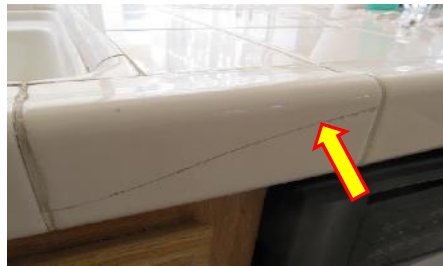
Further Comments: Two small cracks observed on tile in kitchen. Cosmetic only.

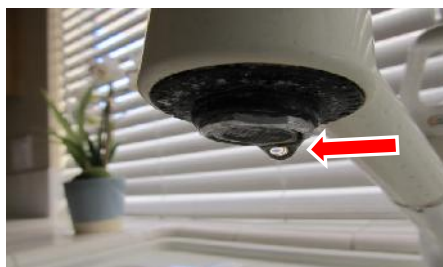
Further Comments: Kitchen faucet has slow drip. Recommend repair.

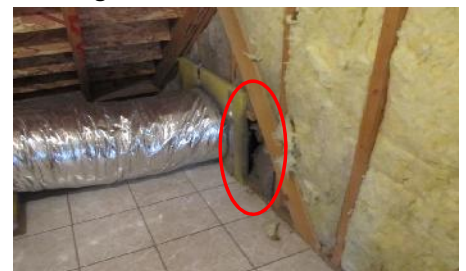
Unit was fully operational at time of inspection. Unable to access furnace for make/model/serial number/year information. Recommend replacing air filters on a regular basis for optimal energy efficiency for HVAC system. The return air duct located under the stairs has a gap as pictured and circled in image 6. Recommend repair to maximize energy efficiency and to ensure proper air circulation.

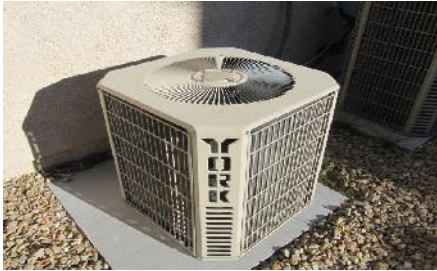
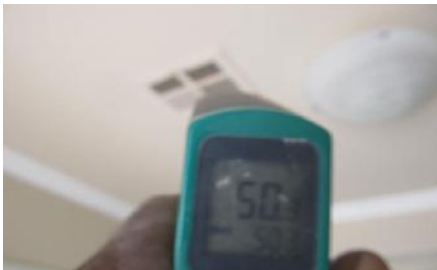
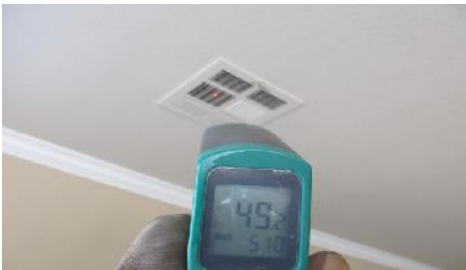
AC was fully operational at time of inspection. Recommend properly anchoring electrical conduit line and replacing insulation around copper tubing.

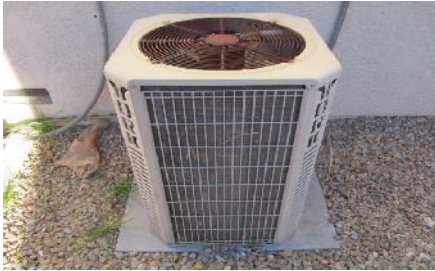
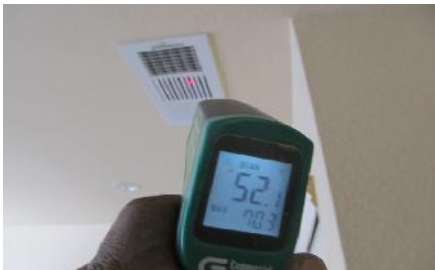
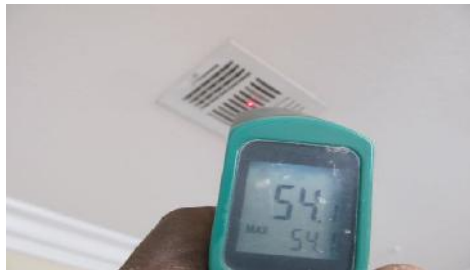
AC was fully operational at time of inspection. Recommend properly anchoring electrical conduit line and replacing insulation around copper tubing.

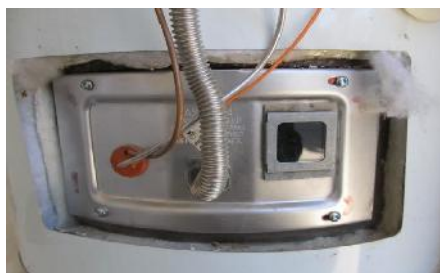
- Vent hood on water heater is not properly attached as pictured in image 2. Minor repair needed.

Vent hood on water heater is not properly attached as pictured in image 2. Minor repair needed.

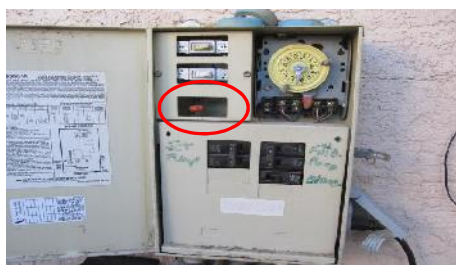
- Opening on panel pictured in image 1 should have a cover. Spa light was not operational. Exposed wires at pool motor junction box should be properly house in conduit to prevent shock hazard. Wires at rear of pool motor are wrapped in tape but should be housed in conduit. Exposed wires observed at 2nd pool motor and should be housed in conduit. Bonding wire is not connected. Switch for spa blower, pictured in image 6 was operational. Recommend repair of all items by a qualified professional.

Further Comments: Opening on panel pictured in image 1 should have a cover. Spa light was not operational. Exposed wires at pool motor junction box should be properly house in conduit to prevent shock hazard. Wires at rear of pool motor are wrapped in tape but should be housed in conduit. Exposed wires observed at 2nd pool motor and should be housed in conduit. Bonding wire is not connected. Switch for spa blower, pictured in image 6 was operational. Recommend repair of all items by a qualified professional.

Missing Cover

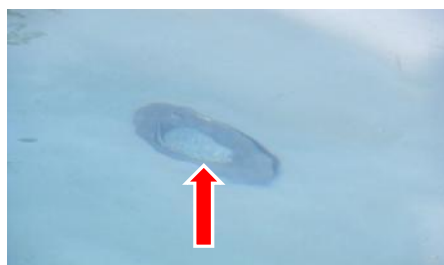
Spa Light

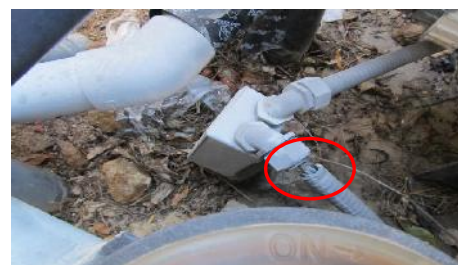
Exposed Wire

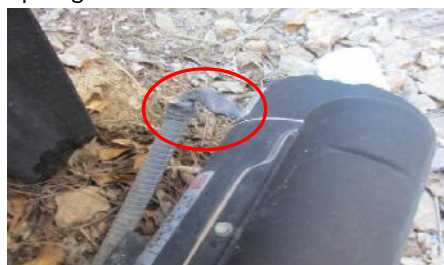
Taped wires

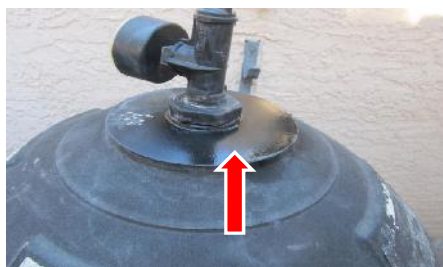
Further Comments: Several leaks observed at pool plumbing pictured in image 1. Leak at top of filter housing pictured in image 2. Recommend repair by a qualified professional.

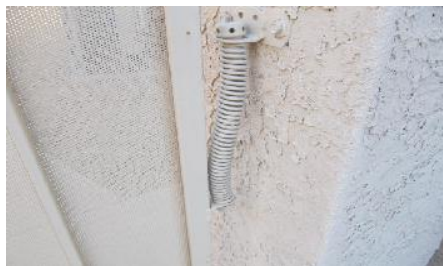
Gate & Fence

Further Comments: Due to this gate being the only access to backyard, and the presence of a pool, recommend adjusting spring so that the gate auto closes. Recommend consulting with local jurisdiction for current pool safety codes and repair accordingly.
