Buyer's Choice Home Inspections LLC

*** Residential Inspection Report ***

March 30, 2019

777 Dream View Ave.
Las Vegas, NV 89147

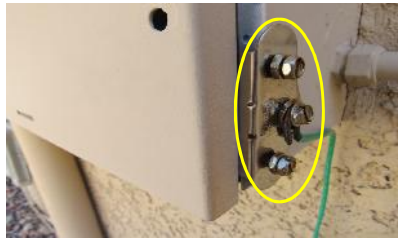
Exterior Panel

Ground wire installed on exterior electrical panel as pictured in image 2, this does not allow door to close. Recommend repair.

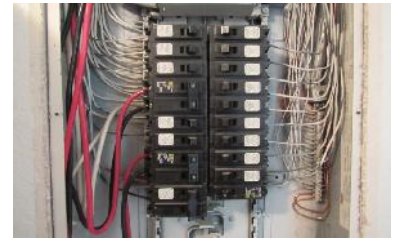
Pantry

Electrical panel inside kitchen pantry is missing 3 of 6 screws on the safety panel. Recommend repair.

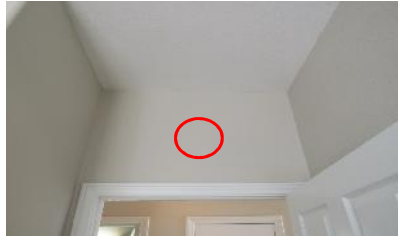
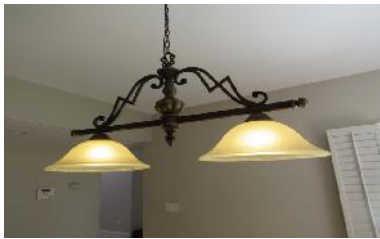
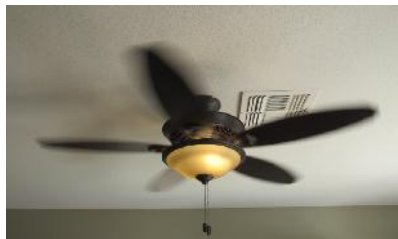
Observation: Smoke detectors generally have a life span of 8-10 years. These units appear original to home. Recommend replacing to ensure proper operation. There are no smoke detectors present in the bedrooms. Recommend installing of safety reasons.

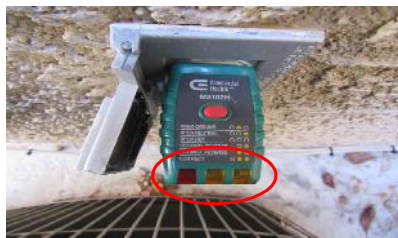
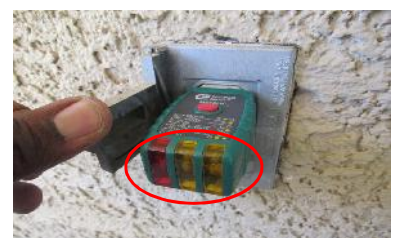
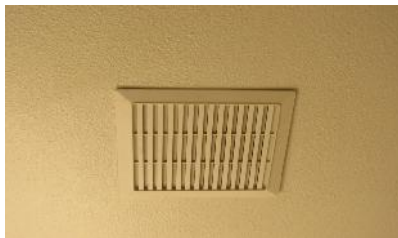
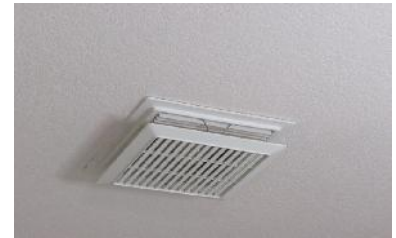
Observation: Outlet at right side of home behind the AC unit and outlet at back patio did not have power. Front porch light, pictured in image 4 is detached as pictured in image 4. 1st floor bathroom exhaust fan powers on but sounds like it's binding/seizing. 2nd floor bathroom exhaust fan is detaching. Exterior carriage lights did not illuminate. They are likely on timers. Recommend evaluation. A few of the lights in the kitchen did not illuminate. Recommend changing bulbs and testing. Outlet at wet bar is missing a cover. Recommend repair.

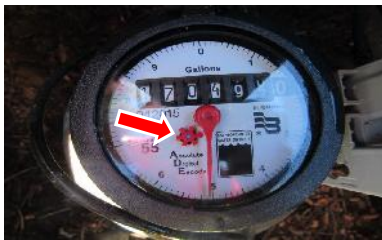
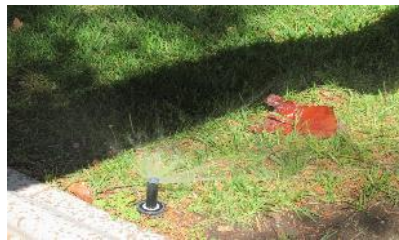
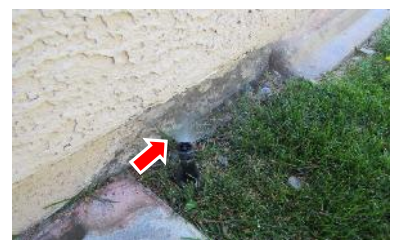
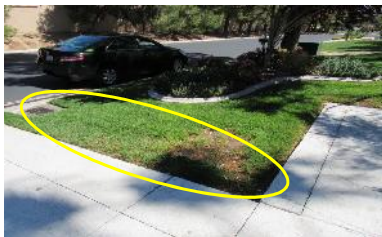
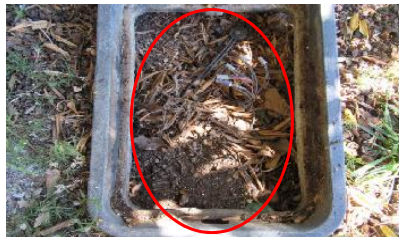
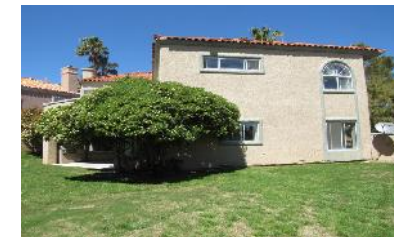
There was movement at main water meter when all water was off to property indicating a leak may be present. Recommend repair. Limited inspection of irrigation was conducted to ensure there are no leaks or broken heads. Sprinkler head at right side of the garage is hitting wall as pictured in image 3. Recommend repair. Section of grass at front yard pictured in image 4, did not have any water flow. Recommend repair. Irrigation box at backyard pictured in image 5 was buried, inspector was unable to test.

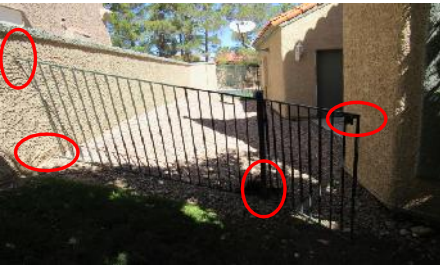
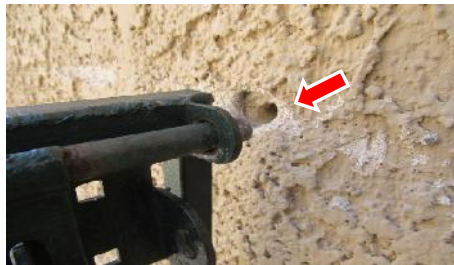
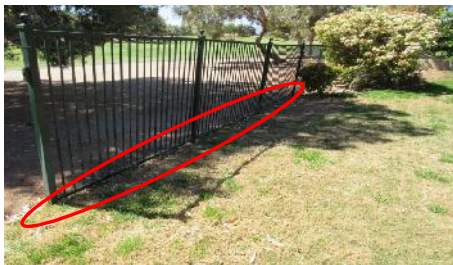
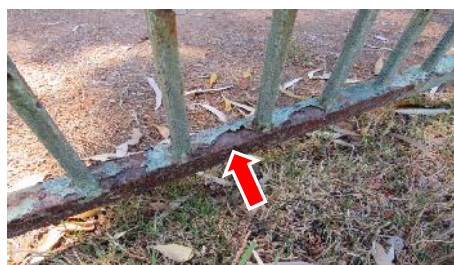
Further Comments: Gate at left side of home pictured in images 1-3, has missing and detaching wall anchors, no wall latch and post is rusted and detached. Recommend repair. Rear fence/gate is weathered and rusted likely from irrigation constantly hitting area. Recommend attention.

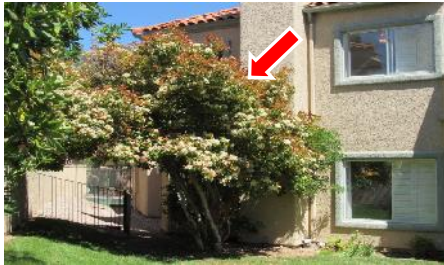
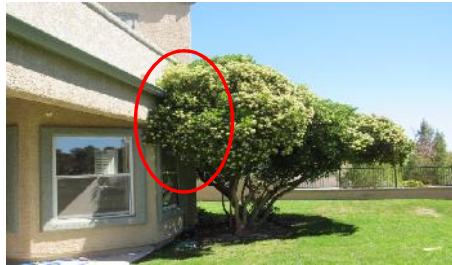
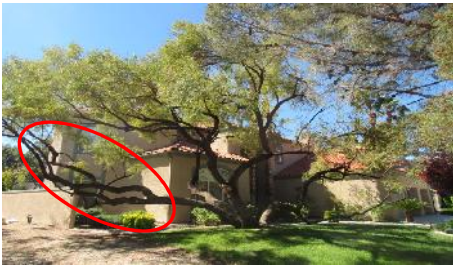
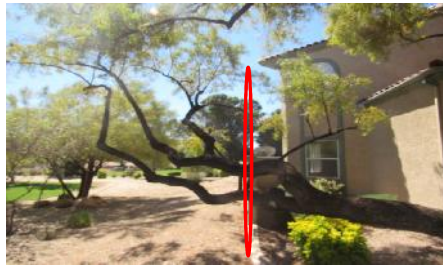
Further Comments: Recommend trimming trees away from home and roof to prevent stucco damage and to ensure proper roof drainage.

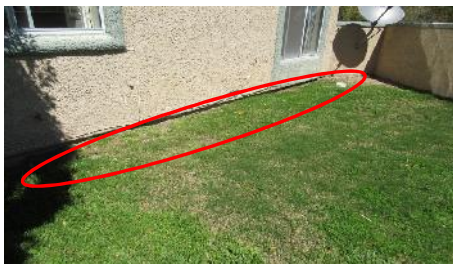
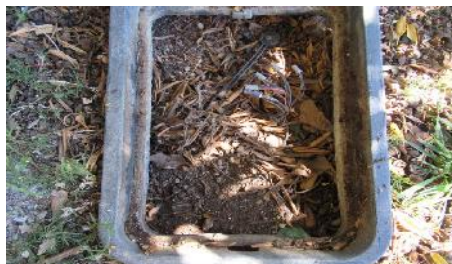
Further Comments: It is recommended that there is a minimum barrier of 18 inches between grass and home to prevent water and pest intrusion. Recommend correction. Inspector was unable to test irrigation for backyard due valves being buried. Recommend evaluation and correction to ensure proper operation and to ensure that water is not hitting home.

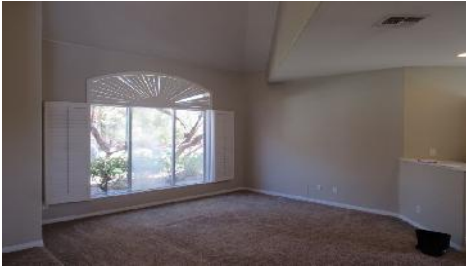
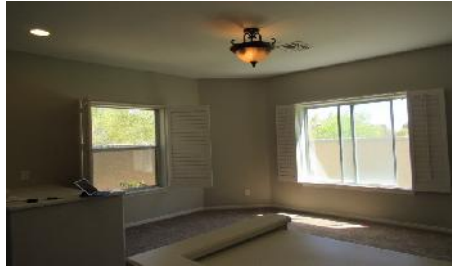
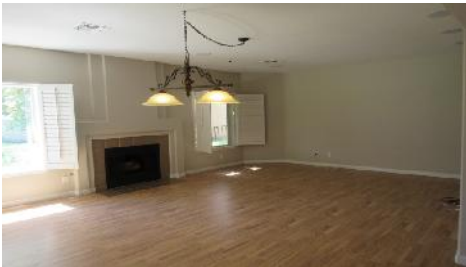
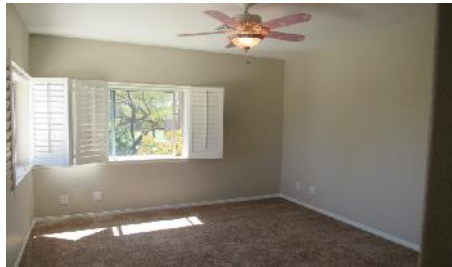
Further Comments: Normal wear and tear observed on interior walls. Cosmetic only.

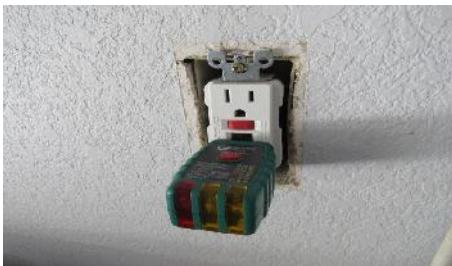
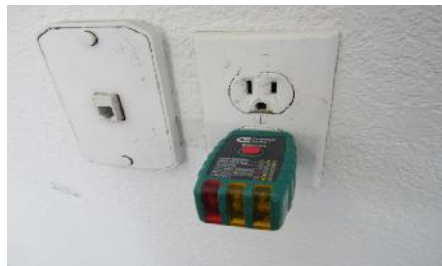
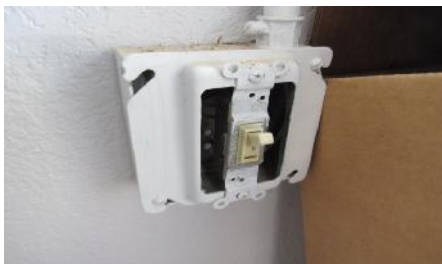
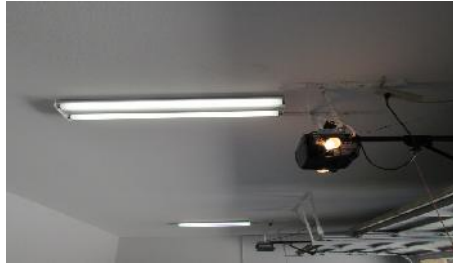
Further Comments: GFCI outlet at left side of garage did not have power and the GFCI would not reset. Only one outlet in the garage had power due to this. Recommend evaluation and repair. Light switch in the garage pictured in image 3 is missing a cover. Recommend repair.

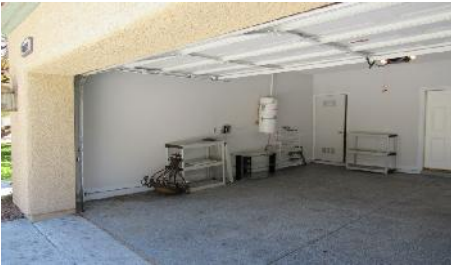
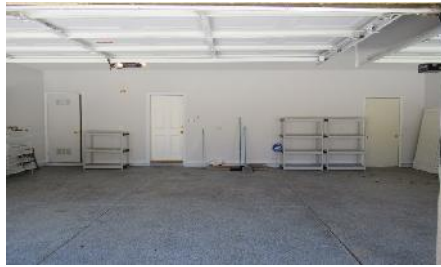
Further Comments: Common settling cracks observed on garage ceiling. Not structural in nature. Cosmetic only.

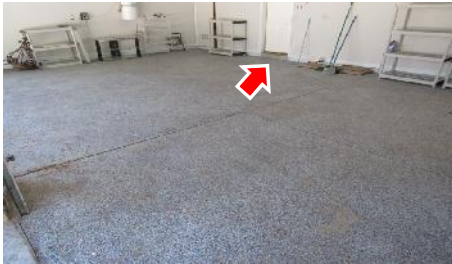
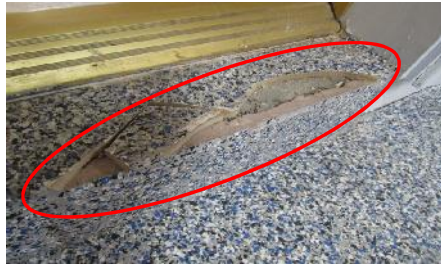
Further Comments: Garage coating is chipped at the entrance to home as pictured in image 2. Recommend repair.

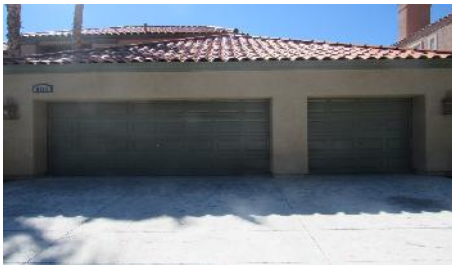
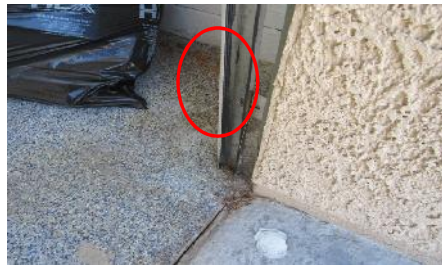
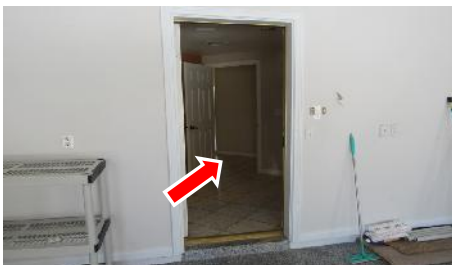
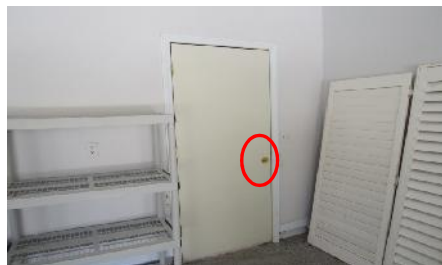
Further Comments: Single car garage door is missing sensors. Sensors should be installed in order to detect obstruction or presence of small children. Recommend correction. Buttons had to be held down for in order for the garage doors to close. Recommend repair. Door leading to interior living space from garage does not auto-close compromising the barrier from the garage to home. Recommend repair. Door leading to side yard from garage only has a deadbolt and not a knob. Door is difficult to operate. Recommend repair.

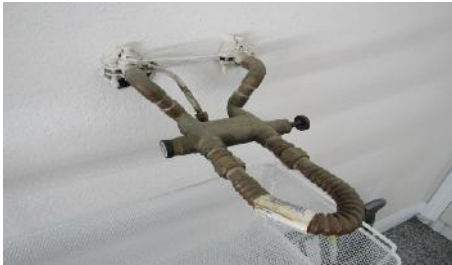
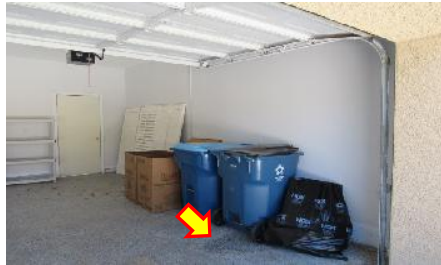
Further Comments: Puddle present in garage where pictured in image 2, moisture was likely coming from trash bag present in area.

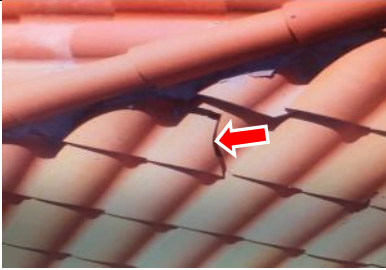
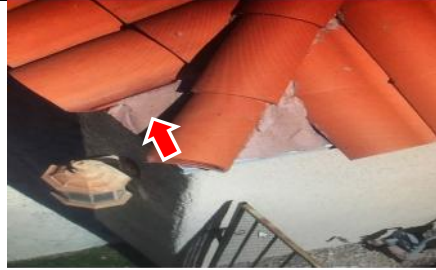
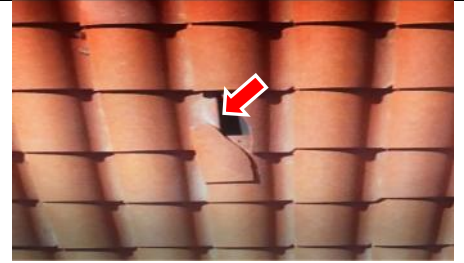
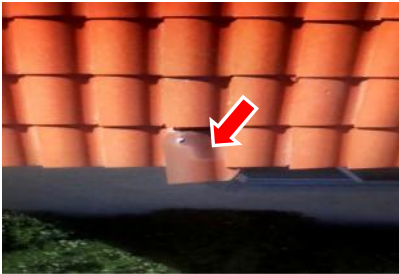
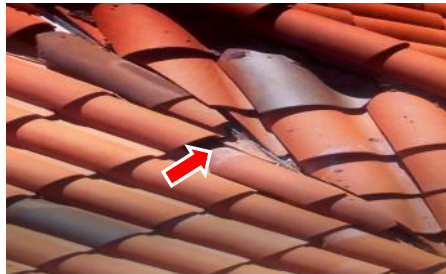
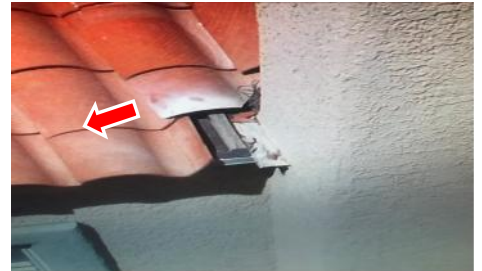
Further Comments: Several cracked, broken, missing and out of place roof tiles observed on roof as pictured. Recommend evaluation and repair by a qualified roofing professional.

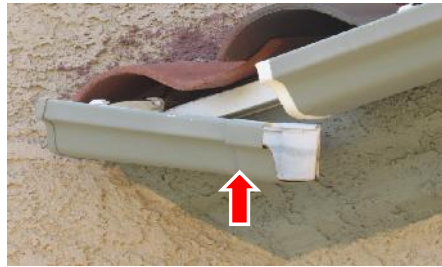
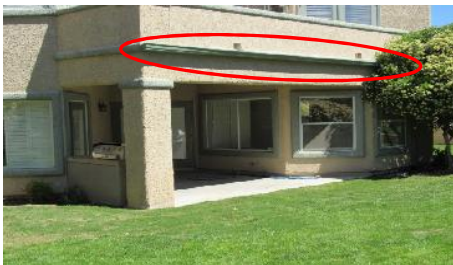
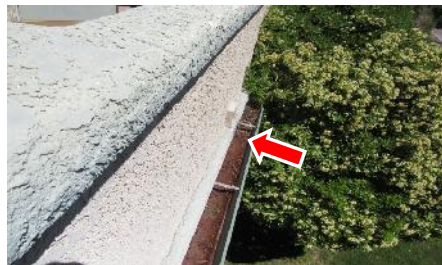
Further Comments: Gutter at left side of home is detached as pictured in image 2. Recommend repair. Recommend clearing all gutters of debris to ensure proper function.

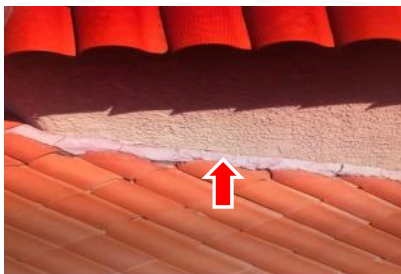
Further Comments: No flashing viewed for roof throughout likely due to age of home. Recommend evaluation.

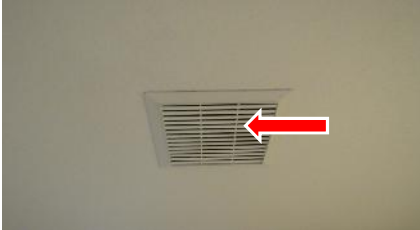
Further Comments: Laundry room exhaust was not operational. Recommend repair.

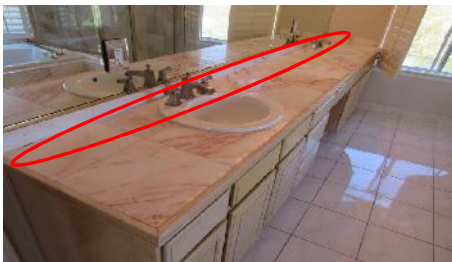
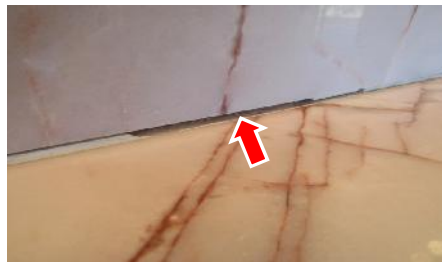
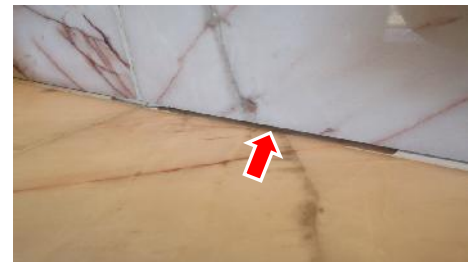
Further Comments: Recommend sealing are behind sinks to prevent water penetration.

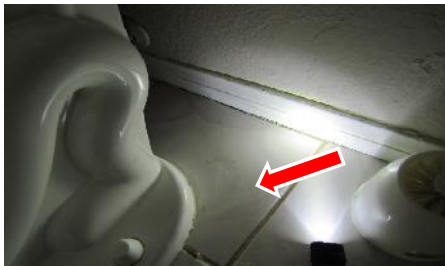
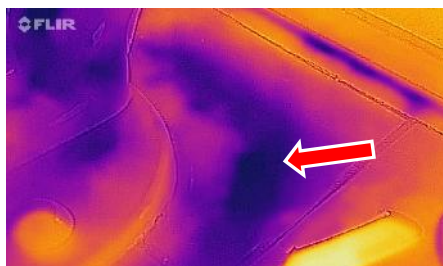
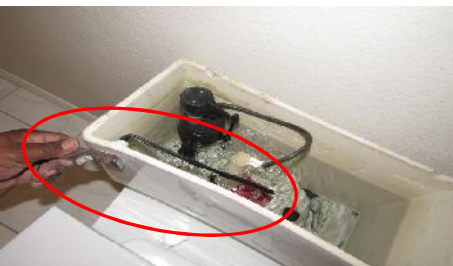
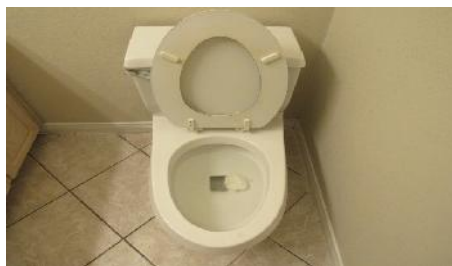
Further Comments: Leak present at rear of master bathroom toilet as pictured in images 1 and 2. Recommend repair. Toilet at 2nd floor hall bathroom does not flush. Flapper appears to be stuck. 1st floor and 2nd floor hall bathrooms constantly run. Recommend repair of all items.

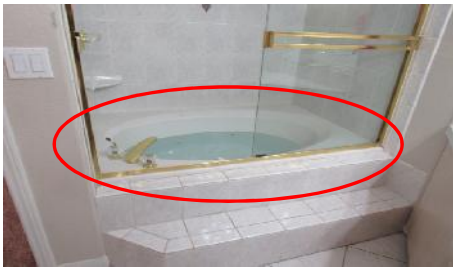
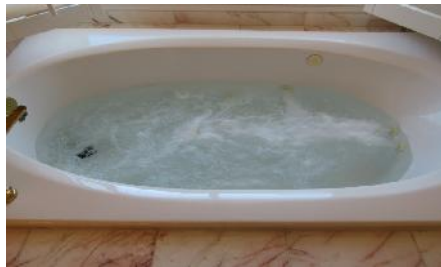
Further Comments: Inspector was unable to locate controls in order to test 2nd floor hall spa tub pictured in image 1. Master spa tub was operational at time of inspection.

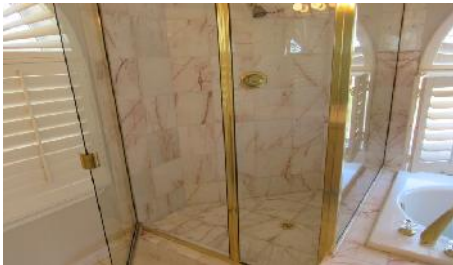
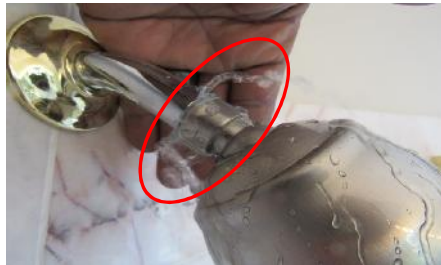
Further Comments: Master showerhead leaks as pictured in image 2 and flange is detached as pictured in image 3. Recommend cleaning and resealing around perimeter of shower pan.

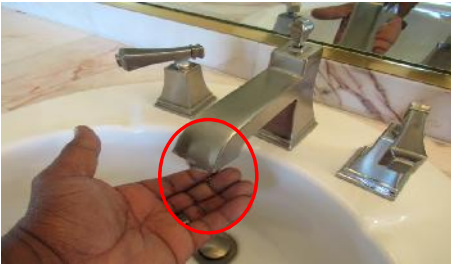
Further Comments: Master bathroom left sink had no water flow. Inspector was unable to manipulate valves underneath with reasonable force. Recommend repair.

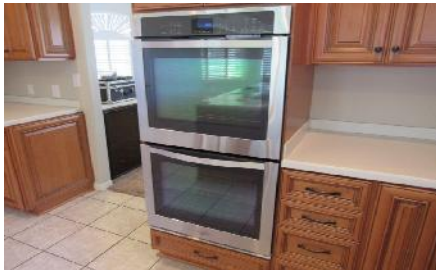
Convection oven fan emitted louder than normal sound. Recommend evaluation.

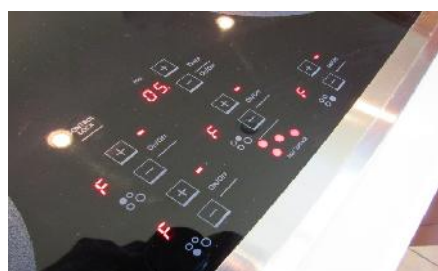
Stove powered on but went off after a short time. Recommend evaluation and repair.

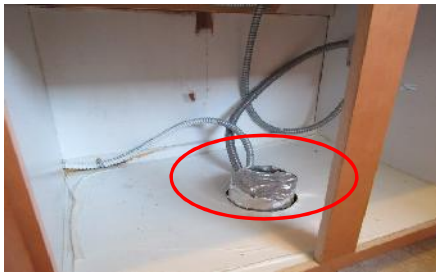
No duct work or fan present for exhaust as pictured. Recommend repair for proper operation.

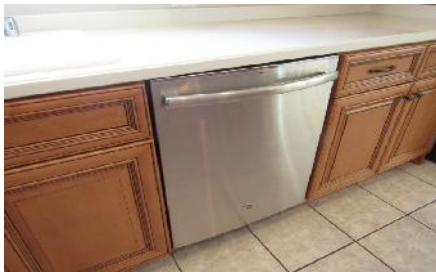
Leak present under sink when dishwasher went through drain cycle as pictured in image 3. Recommend repair.

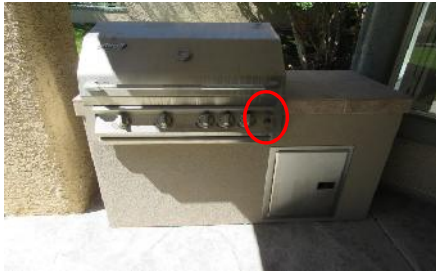
Grill igniter was not operational. Recommend repair.

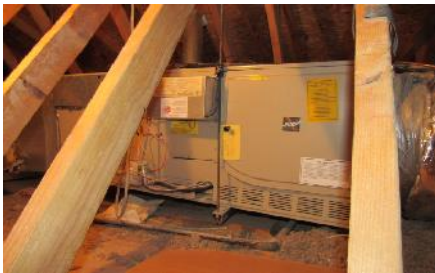
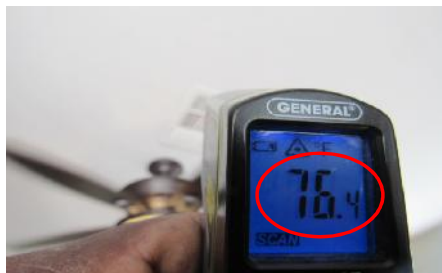
The furnace operating the 2nd floor was not operational. There should be a minimum split of 15 degrees. This unit only achieved a 3 degree split. Recommend evaluation and repair. Evidence of rust discharge present from condensation line as pictured in image 3. Recommend evaluation and servicing.

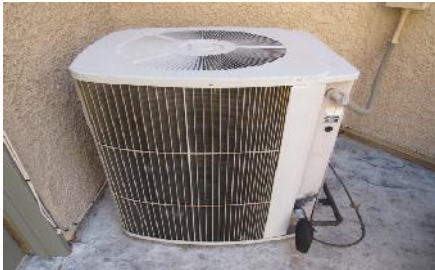
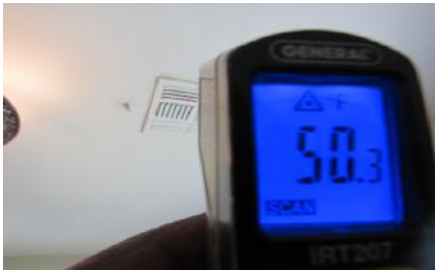
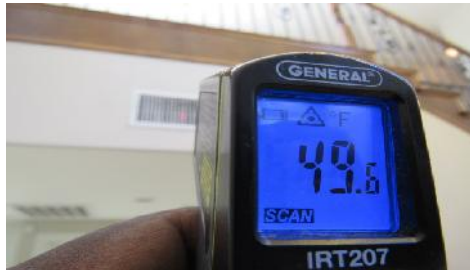
Unit was fully operational at time of inspection. Recommend insulating copper tube pictured in image 2.

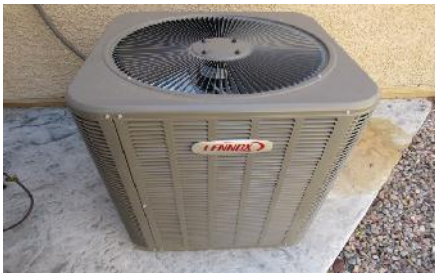
AC unit servicing the 2nd floor did not achieve optimal temperatures. There should be a minimum split of 15 degrees between return and supply air. This unit only achieved a split of 6 degrees. Recommend evaluation and repair by a qualified professional.

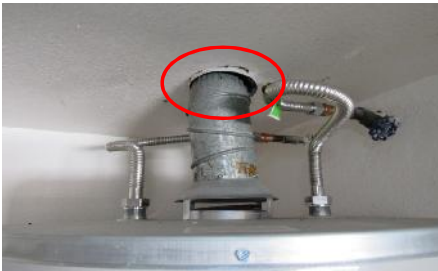
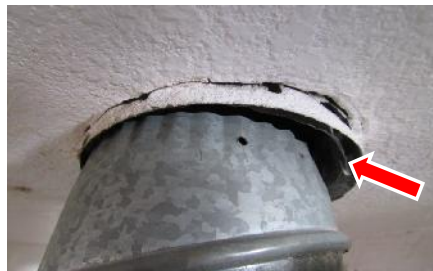
- Exhaust vent for water heater is not attached as pictured in images 1 and 2. Recommend repair.

Exhaust vent for water heater is not attached as pictured in images 1 and 2. Recommend repair.
